NACA TN 3190

FATIGUE INVESTIGATION OF FULL-SCALE
TRANSPORT-AIRPLANE WINGS

SUMMARY OF CONSTANT-AMPLITUDE TESTS THROUGH 1953

By M. J. McGuigan, Jr., D. F. Bryan, and R. E. Whaley

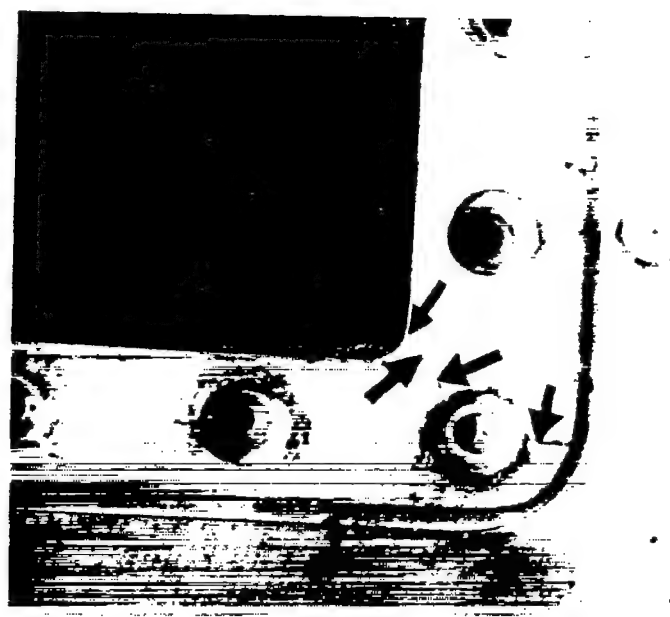
The type IV failures occurred in internal reinforcing doubler plates around cutouts D and E, located outboard of span station 214 and immediately forward of the 30-percent spar. A photograph of this type of failure is presented as figure 6(d). These cutouts had cover plates that were fastened to the reinforcing doubler plate with machine screws and channel nuts. The failures originated in the screw holes on some wings and in the smaller-radius corner of the internal doubler plate on others, frequently occurring very early in a test. These failures spread into the skin on only two occasions but in no case did they grow to more than a few inches in length.

(d) Type IV failure in reinforcing doubler plate at inspection cutout D. L-77924

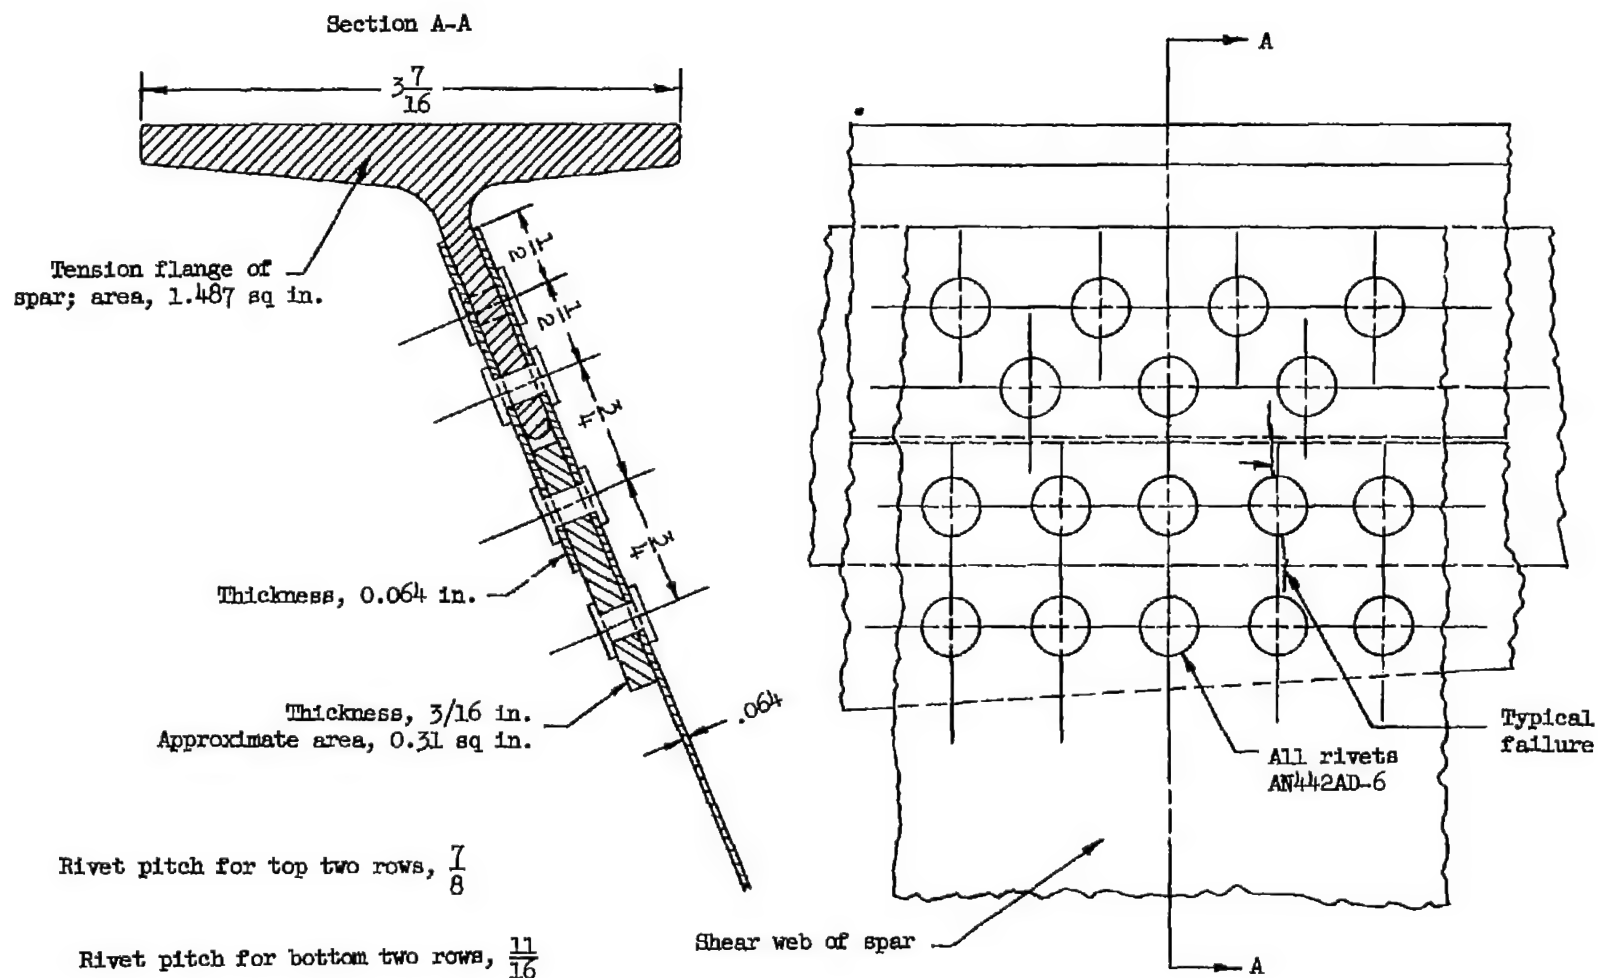
The type III failures occurred at span station 120 in the riveted joint connecting the shear web to the tension flange of the front spar. Since this location was very difficult to photograph, a drawing of the details of this joint is shown in figure 7. The cracks usually progressed vertically through the shear web and were accompanied by a crack in a small piece of skin over the spar cap.

Figure 7.- Details of riveted shear joint at span station 120 in which type III failures occurred.
